RE: Murphy v. Southern Energy Homes

On October 24, 2007 I inspected the residence of Kelly Murphy located at 5489 Washington Ferry Rd., Montgomery, AL.

Evaluation of 5/16" Vinyl Covered
Gypsum (Murphy Home) to ASTM C1396

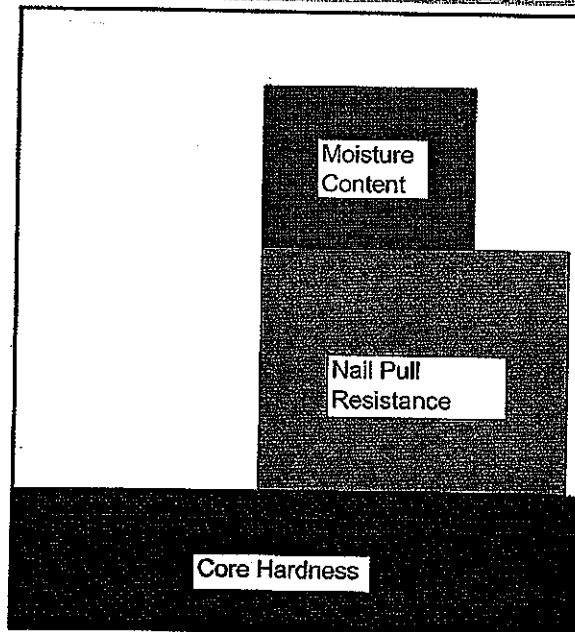
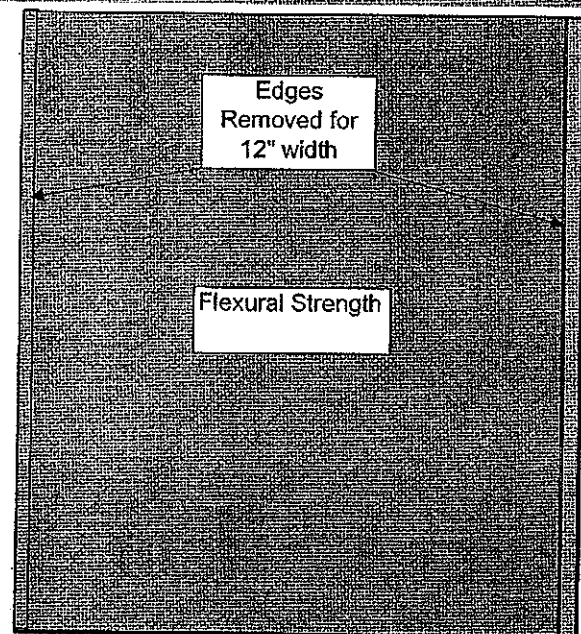
Typical Sample Removal Locations

Sample Condition: See attached photographs for "As Received" condition. The sample sizes and weights were taken with the plastic wrap sealed and then samples were chosen at the maximum, minimum, and average grams per square inch to act as a sampling method.
